## Changes in sitting posture after adjusting a wheelchair

- An interventional case approach in VDT work —

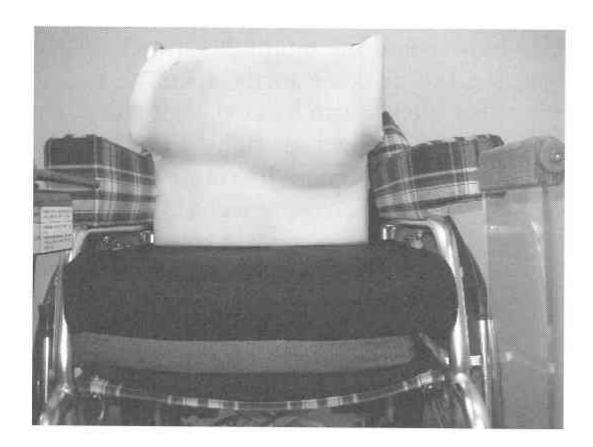
To solve the above problems 1 to 5 of the wheelchair, the following measures were taken: for problem 1, while the person was sitting in the wheelchair, we fastened an appropriate Velcro. For 2 and 3, the depression of the seat surface was flattened with a curved cushion. For the back support cushion of 4, urethane foam was carved to conform to her scoliosis shape; and lateral supports on both sides of the back support were attached in order to maintain posture while working (Figure 1).

Figure 1 Back Support cushion with Side Supports

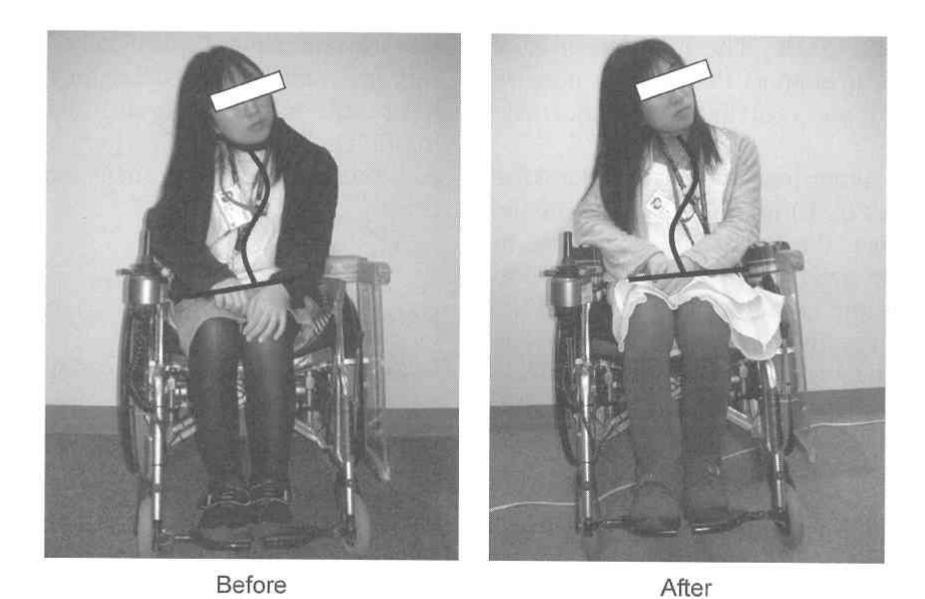
The wheelchair sitting posture was as follows: she leaned to the right with arms on the elbow rests. As she did VDT work, the trunk and pelvis were in anteversion, and the right elbow was not on the desk.

After these adjustments, the trunk was stabilized and the person could lean on the back support comfortably, and, with the lateral supports, lean the trunk less to the right. The forced sitting posture when shifting to the right was thereby alleviated (Figure 2). For problem 5, we changed the controller for one which opens to the side. This shortened the distance to the desk by 7 cm, eliminating the need of resorting to anteversion of the trunk and pelvis; and her reach distance was thereby extended (Table 1). She was then able to put her right elbow on the desk, which facilitated maintaining a comfortable posture.

Figure 2 A Frontal view of the changes in sitting posture before and after intervention

Thus, after this adjusting, the problem of trunk and pelvis leaning to the right was overcome. The back support and lateral support cushions adjusted to her back and trunk meant more comfortable sitting; and the controller opening to
